# The “Placida Bunk House”

Charlotte County Parks, Recreation  
and Cultural Resources

Final Report

September 2008

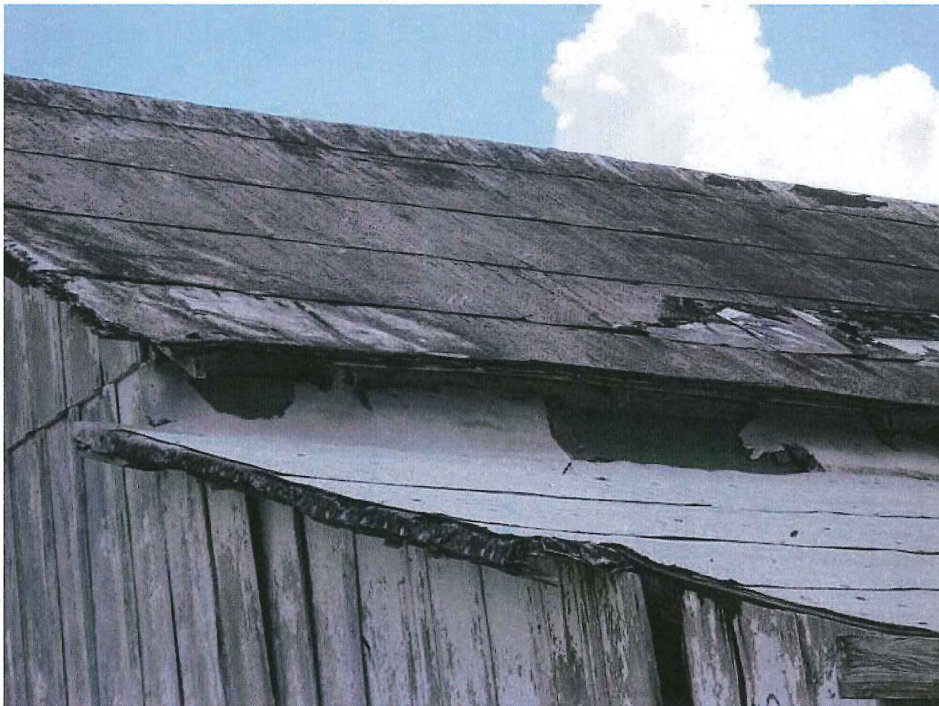
Condition: The roof covering is in severely deteriorated condition.

South west corner, deteriorated roof deck after roof patch in place. Some rafter ends require repairs, gutters missing from fascia.

- Remove existing roof membrane over damaged areas and inspect existing roof deck, particularly at eaves. Replace damaged boards with new tongue and groove boards, pressure treated kiln dried heart pine.
- Replace damaged roof rafters with pressure treated southern yellow pine, cut to match dimensions, sizes and profiles of the original rafters.
- Apply new bituminous membrane roofing system over the entire roof. Apply new dark bronze aluminum drip edge metal along eaves and raking gables. This will serve as a stable, temporary cover until the building can be fully restored.

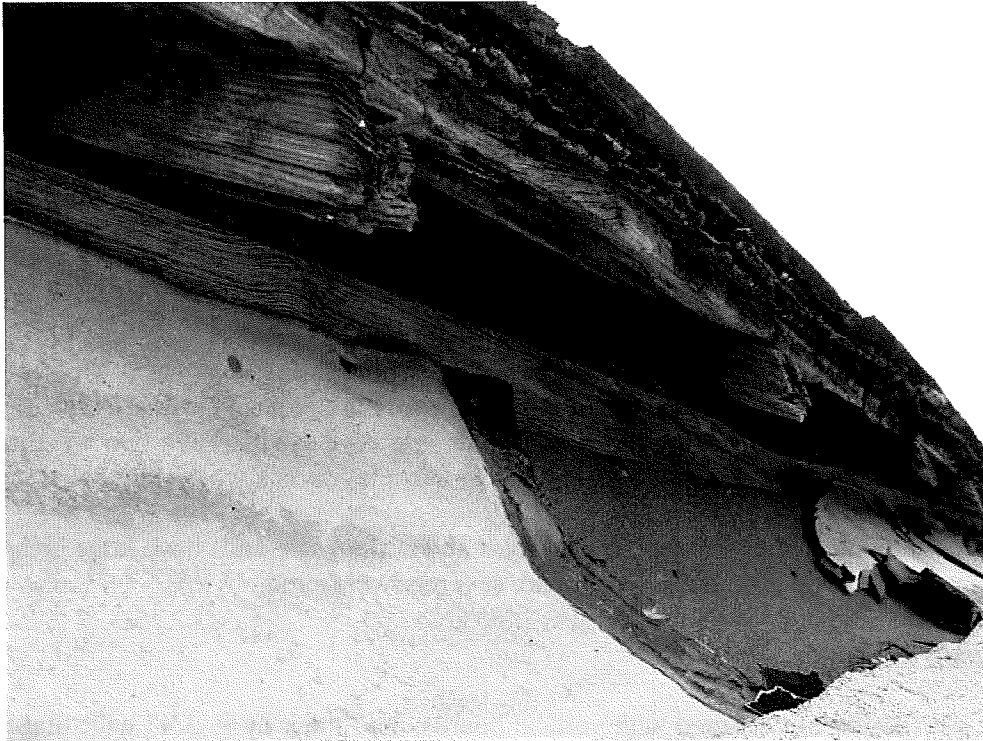
Detail of upper roof layers

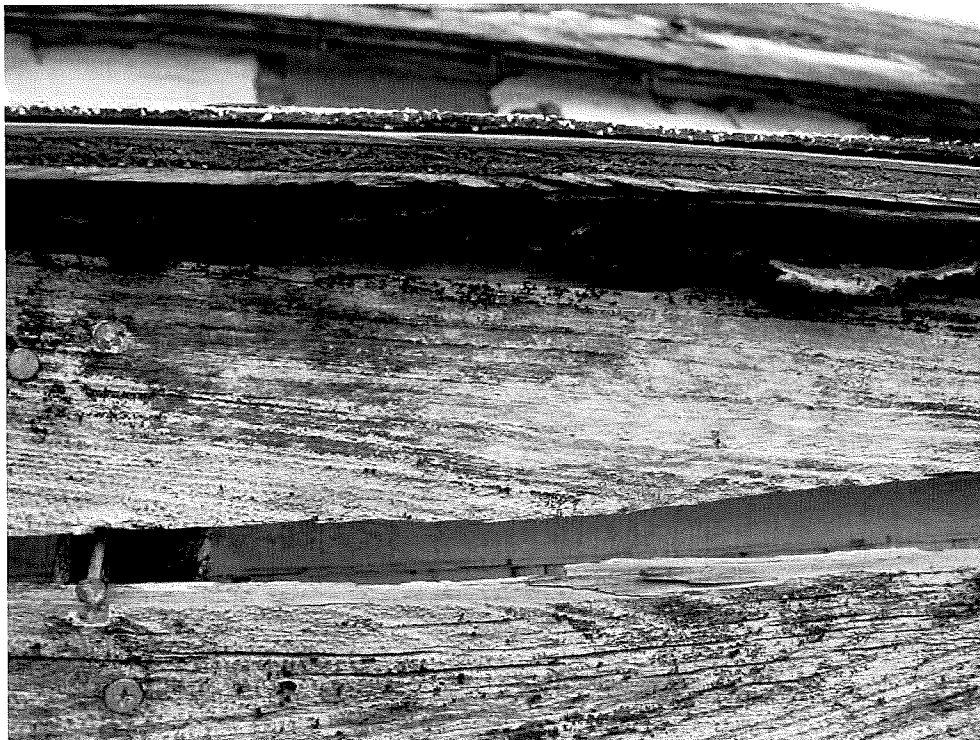
Detail of the lower roof layers, on top of modern plywood layer, remnant of the fascia board nailed to ends of rafters

Condition: There is extensive damage and rot in many of the rafter ends, where the roof covering has deteriorated. The fascia remnants are badly damaged.

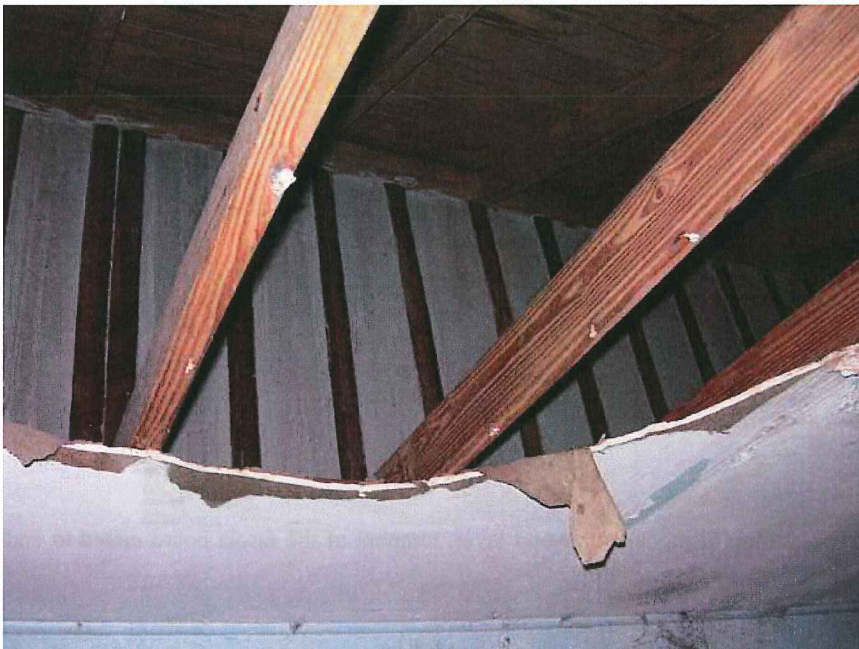
Condition: Some of the original beveled battens have been replaced with the square battens. The battens were removed from the south face of the original two story wall section, some battens on the interior face remain in several locations.

South wall of two-story section, battens were removed for addition

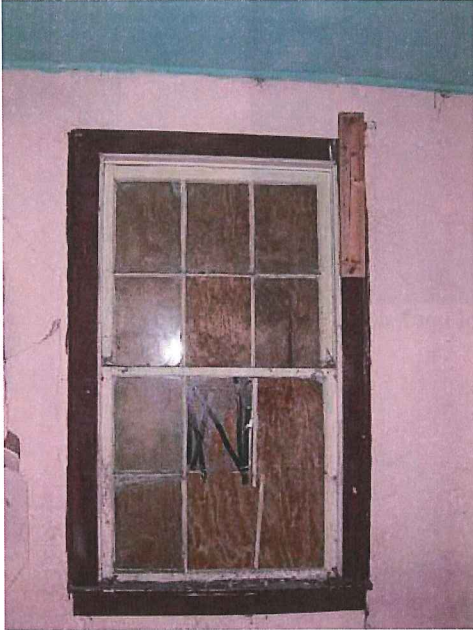
East window typical 6 over 6

Condition: The windows are overall in poor condition and will need extensive restoration.

- Windows will require major restoration and major reconstruction
  - Remove the sash from the frames
  - Make structural repairs to the wall framing as described in the section on framing repairs
  - Remove existing glazing and salvage where possible
  - Replace damaged, rotted sections with new heart pine wood, match existing members in size, profiles, thickness
  - Frames and sash of the windows which were painted, restore the paint finish using top quality primer and two coats of paint, color to match the first painted surface from the period of significance.
  - Reglaze and replace sash in the frames.

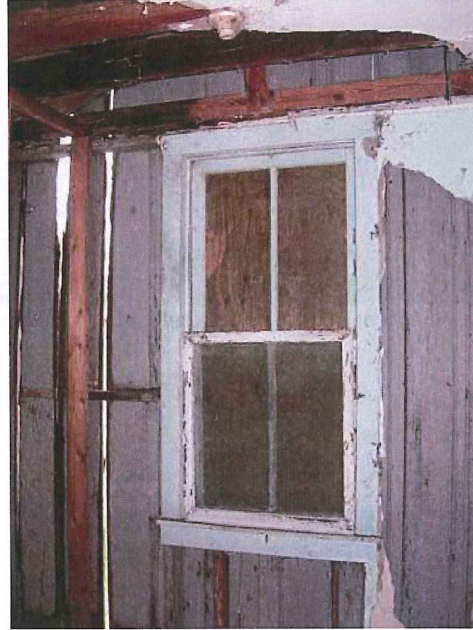
West window 2/2 design

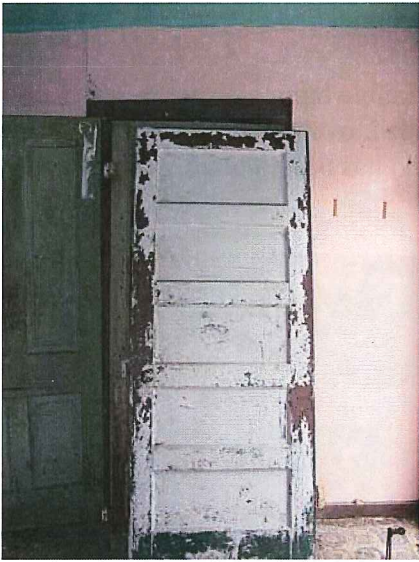
Condition: The doors are salvageable and reusable. The hardware should be salvaged for possible repairs.

Interior view of north (rear) door on east end

- The exterior doors may be salvaged and repaired.
- One of the exterior door openings will need to be widened for access, the new door should match the five panel design of the other exterior doors.
- Repair and restore casings.

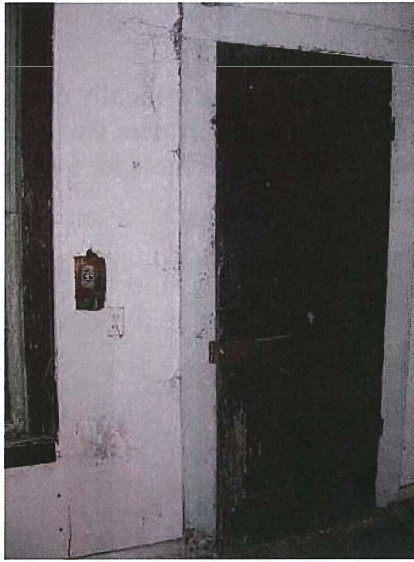
Interior view of north door, west end

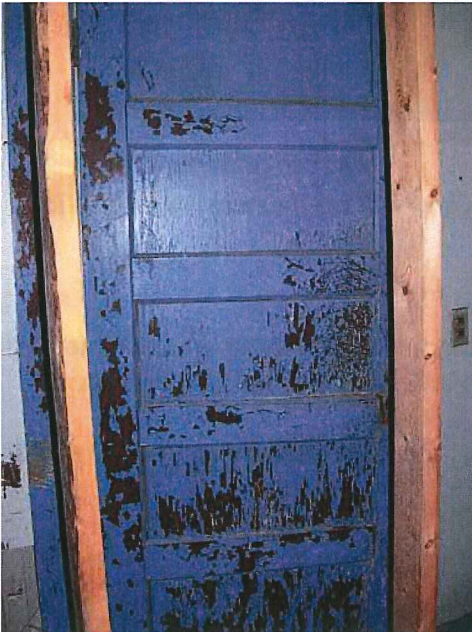
Interior view of south (front) door

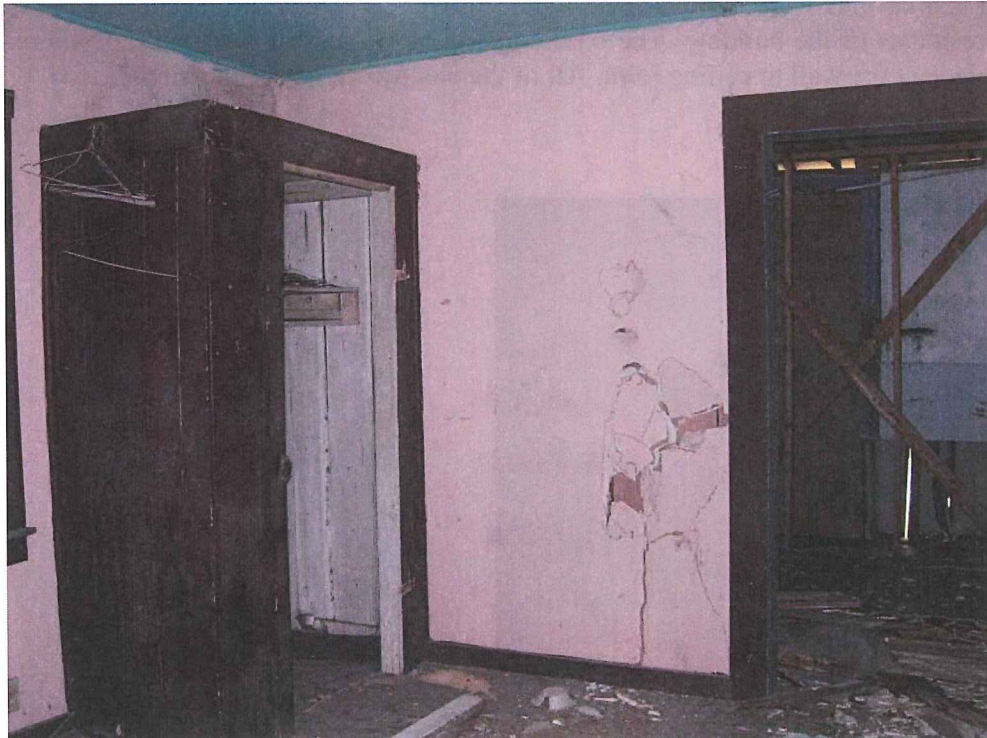
Several layers of sheet flooring have been applied over the original wood tongue and groove floor. The flooring is in poor condition.

Southeast corner with modern closet. Note the exposed section of vertical board finish on the south side of the wall.

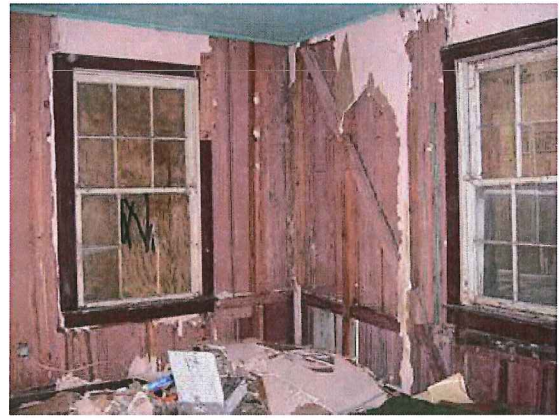
Northeast corner after removal of gypsum board

The walls and ceiling are covered with a thin layer of paper faced gypsum board, that is painted. This material was added after the mid 1950s. The wallboard material is in poor condition.

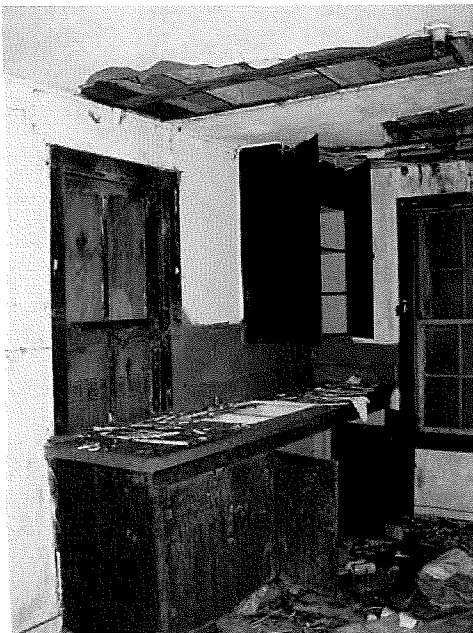
Northwest corner

Condition: The built-ins are in poor condition overall, and should be documented before removal.

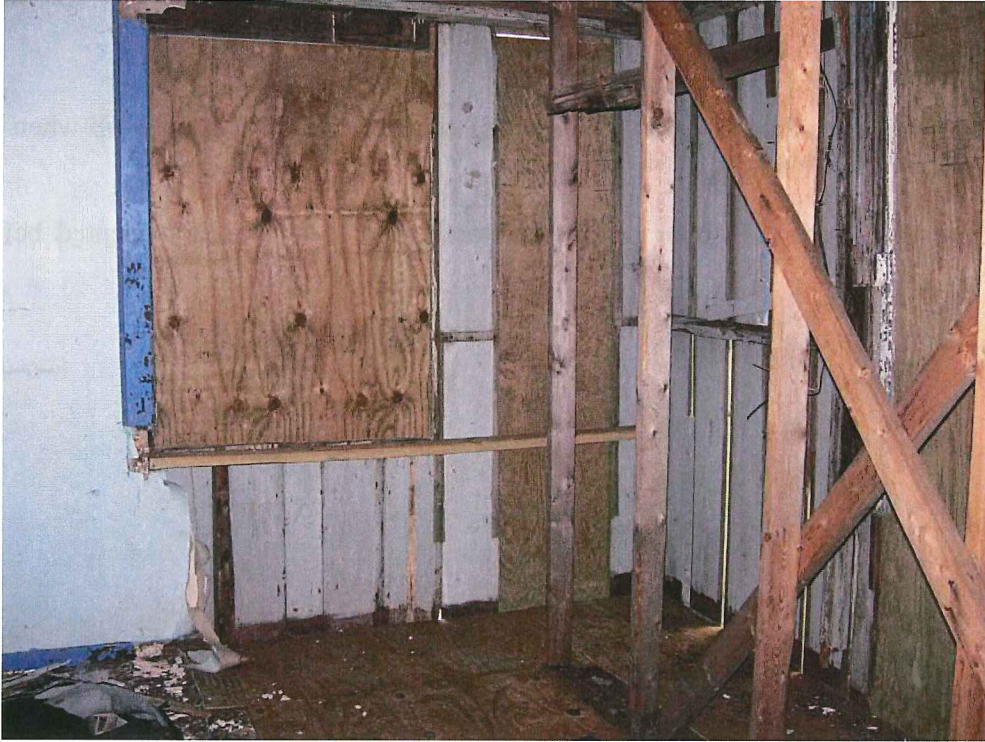
The walls and ceiling are covered with a thin layer of paper faced gypsum board, that is painted. This material was added after the mid 1950s. The wallboard material is in poor condition.

East wall of south room with wallboard removed

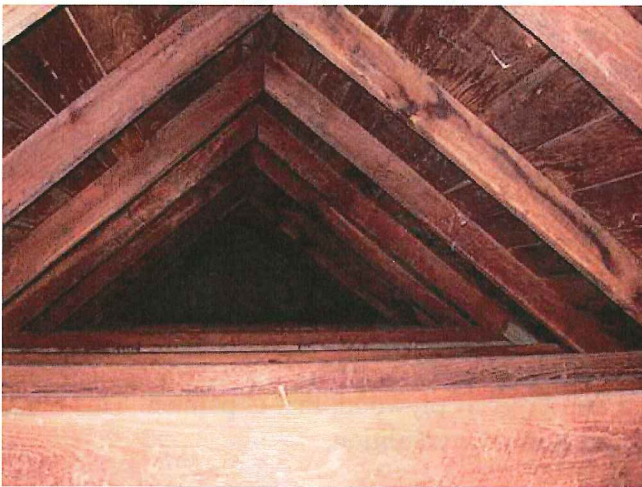
Condition: The rafters are in good condition on the interior, but some exterior rafter ends exhibit significant decay.

Attic rafters and collar ties

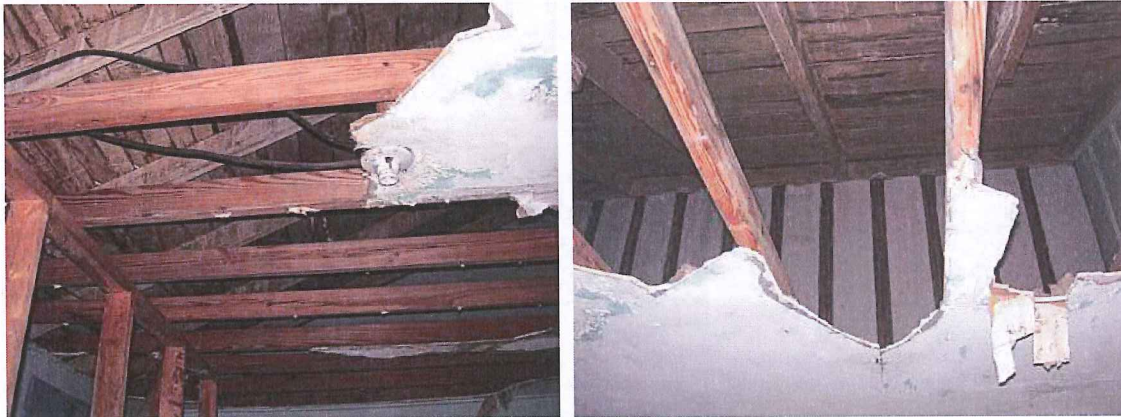
Condition: The rafters are in good condition on the interior, but some exterior rafter ends exhibit significant decay.

Roof rafters at shed roof section with later ceiling joists and tongue and groove roof deck

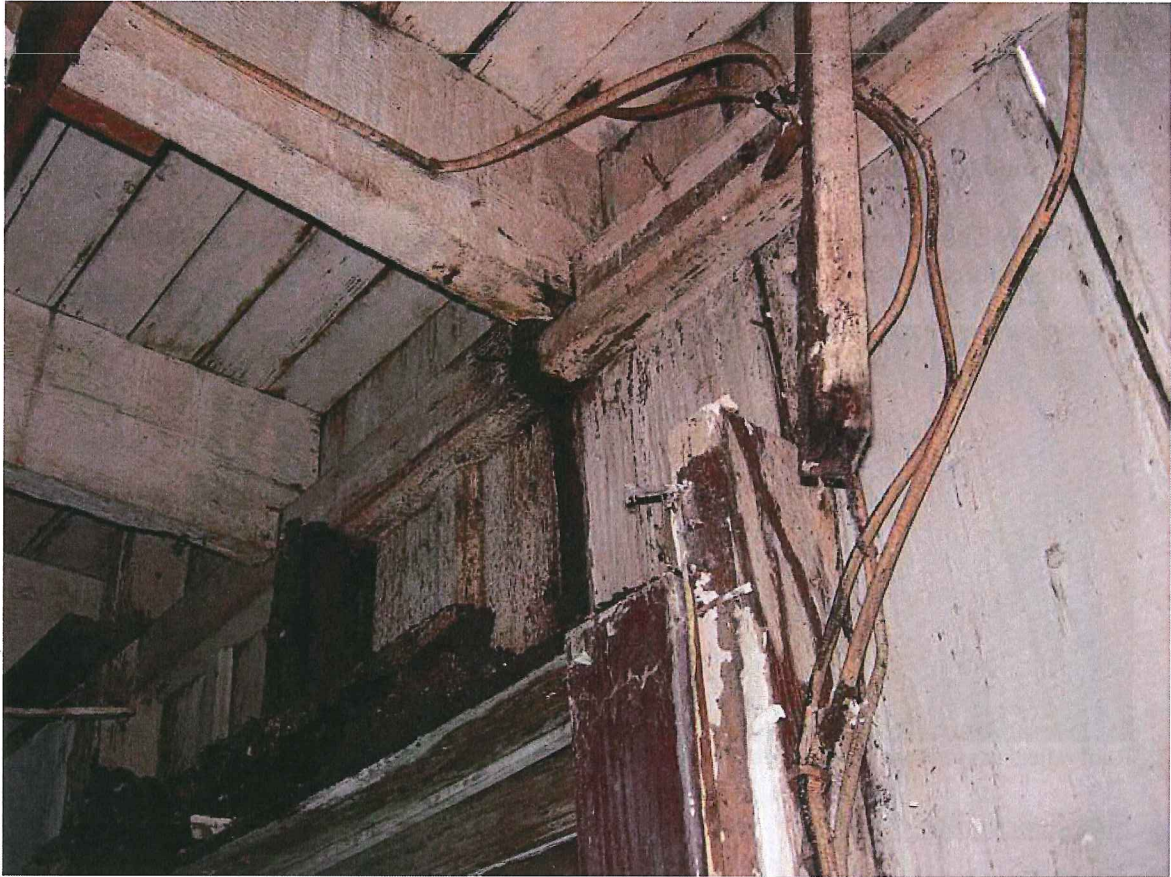
Condition: The joists are in good condition on the interior, but some exterior bearing ends exhibit significant decay.

Second floor joists, north wall, notched over ledger which is notched into the studs. Note stud to right of opening was cut off.

Condition: The two story wall framing has been altered on both the north and south walls. A number of the studs have been cut at the first floor windows. A few studs are missing entirely and others have been damaged by rot and insects. The exterior wall boards were applied vertically and appear to bridge the span between horizontal framing members.

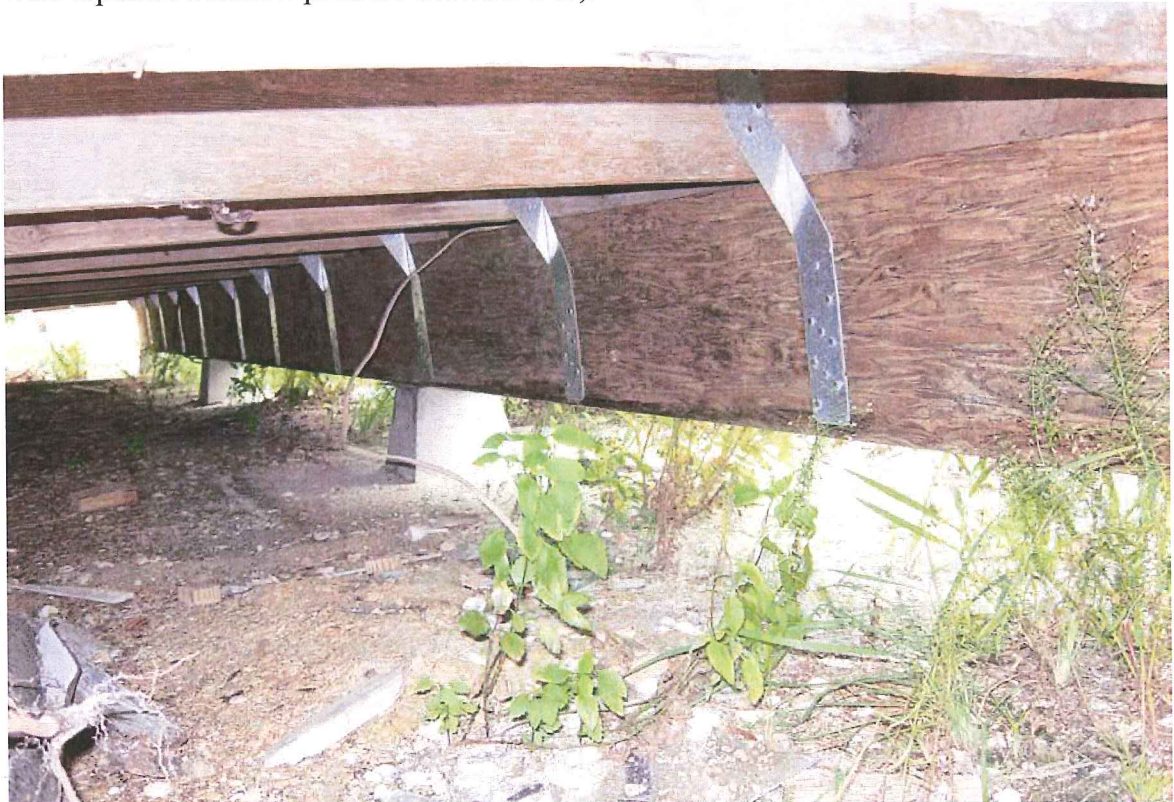
Condition: The joists are generally in good condition and have been connected to the new floor beams with metal connectors. Some joists have cracks and damage and need to be repaired or reinforced with new pressure treated "sistered" joists (several perimeter joists were replaced with new pressure treated 2 x 8s).

Floor joists on new foundation system with galvanized connectors

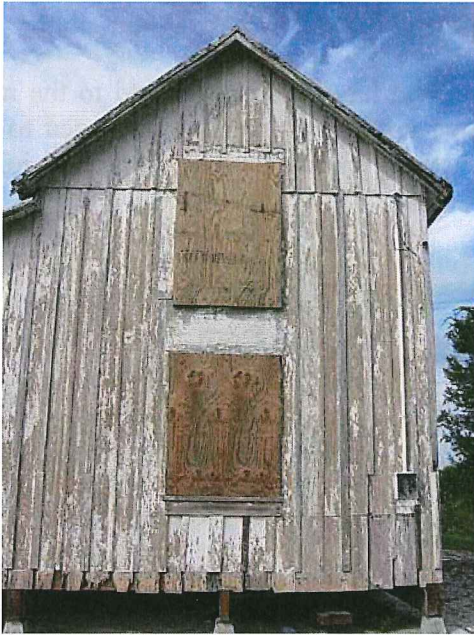
Description: The original electricity was installed in 1950, with the original service fuse box without a cover still in place on the east façade. The interior electrical system consisted of six

surface mounted lights and two outlets, all of which are in place. Additional outlets were added after the later 1950s. The electrical system is not functional.

East wall with fuse box

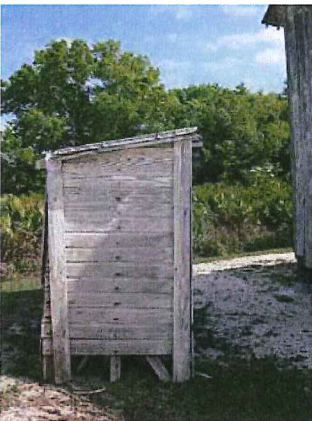
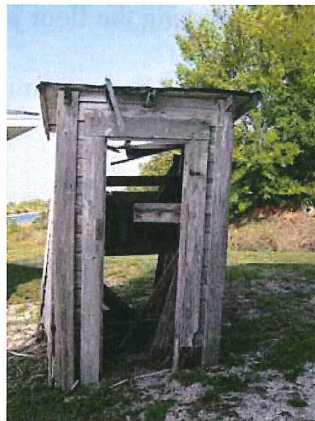
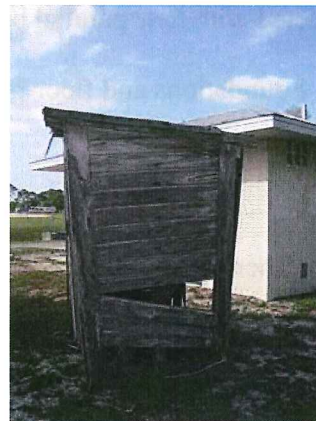
Outhouse: the wood outhouse structure has been relocated to the site, on the west side of the building. About 50 inches square, this small structure is constructed from 2" x 4" studs at corners, with diagonal set-in bracing and is clad with 5 1/2" wide novelty siding. The structure is in poor condition and requires extensive reconstruction.
